REVISED REPORT

**THE IMPACTS OF CYCLONE IDAI IN THE BUPUSA
TRANSBOUNDARY BASINS IN MOZAMBIQUE
AND ZIMBABWE**

**Prepared by the Centre for Applied Research with Hatfield
Consultants Africa**

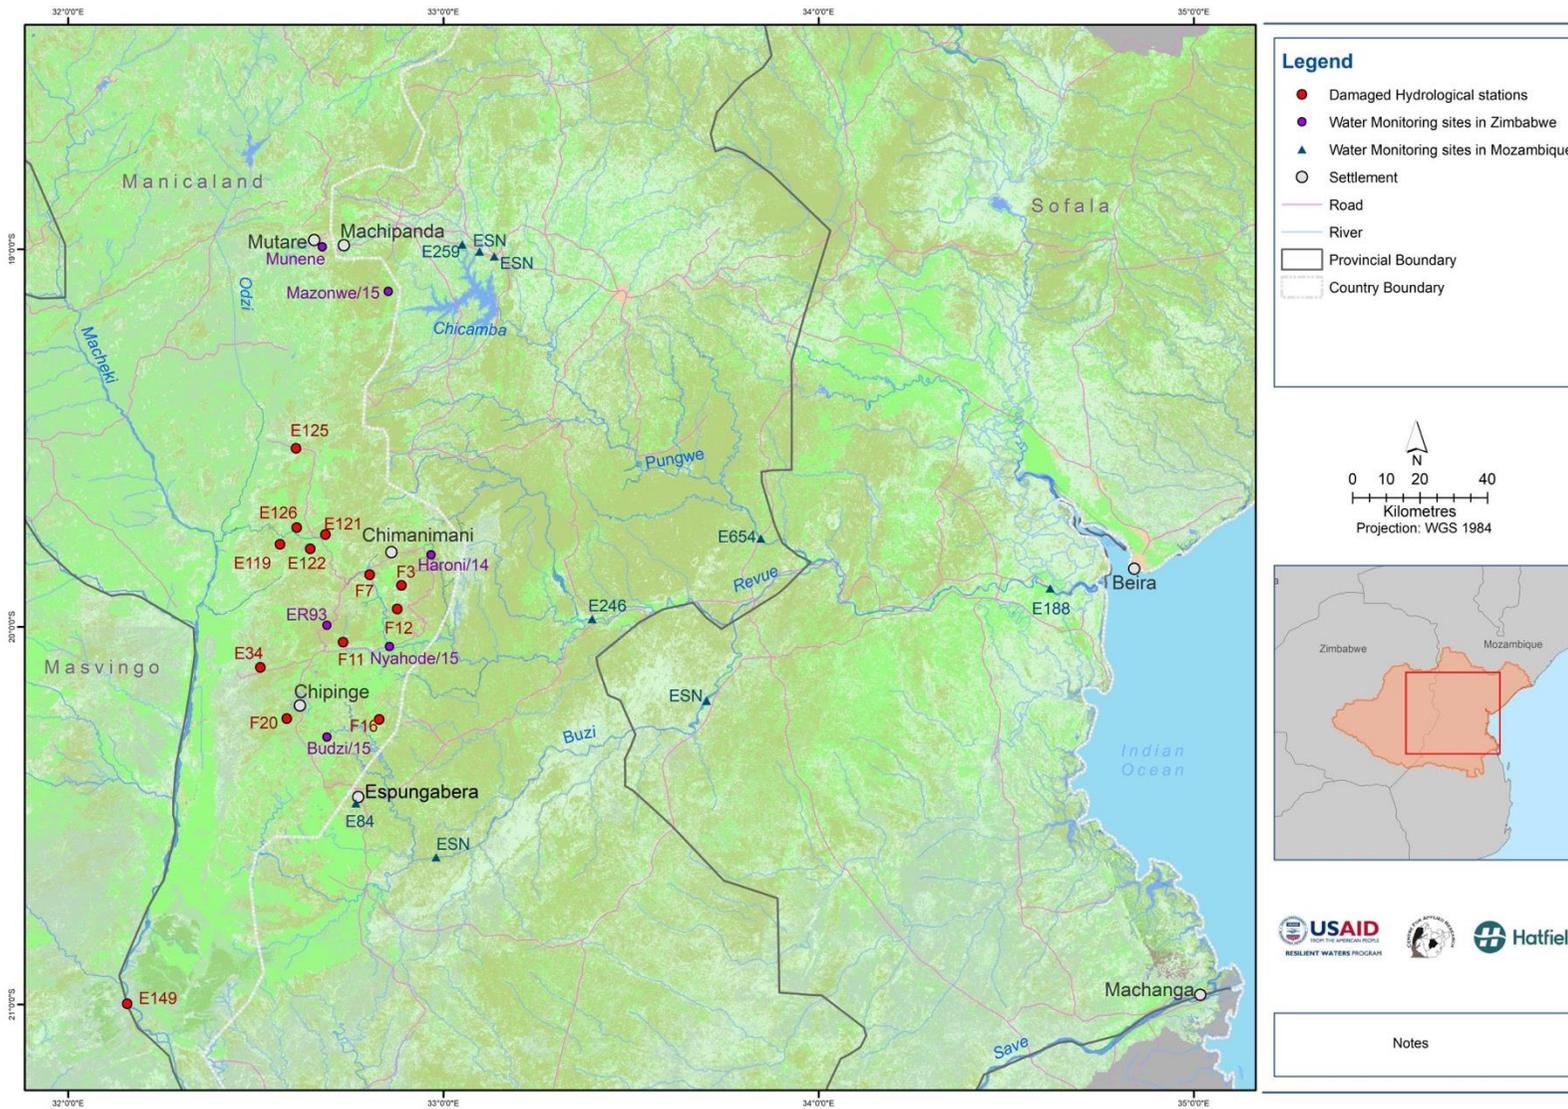
Monitoring flows is currently difficult as numerous hydrological monitoring stations along the Save River in Chimanimani and Chipinge districts were either damaged or completely washed away during the Cyclone Idai event. The damaged stations along the Buzi River and district are listed in Table 2, and illustrated in Figure 3.

Figure 3: Hydrological monitoring stations damaged during Cyclone Idai.

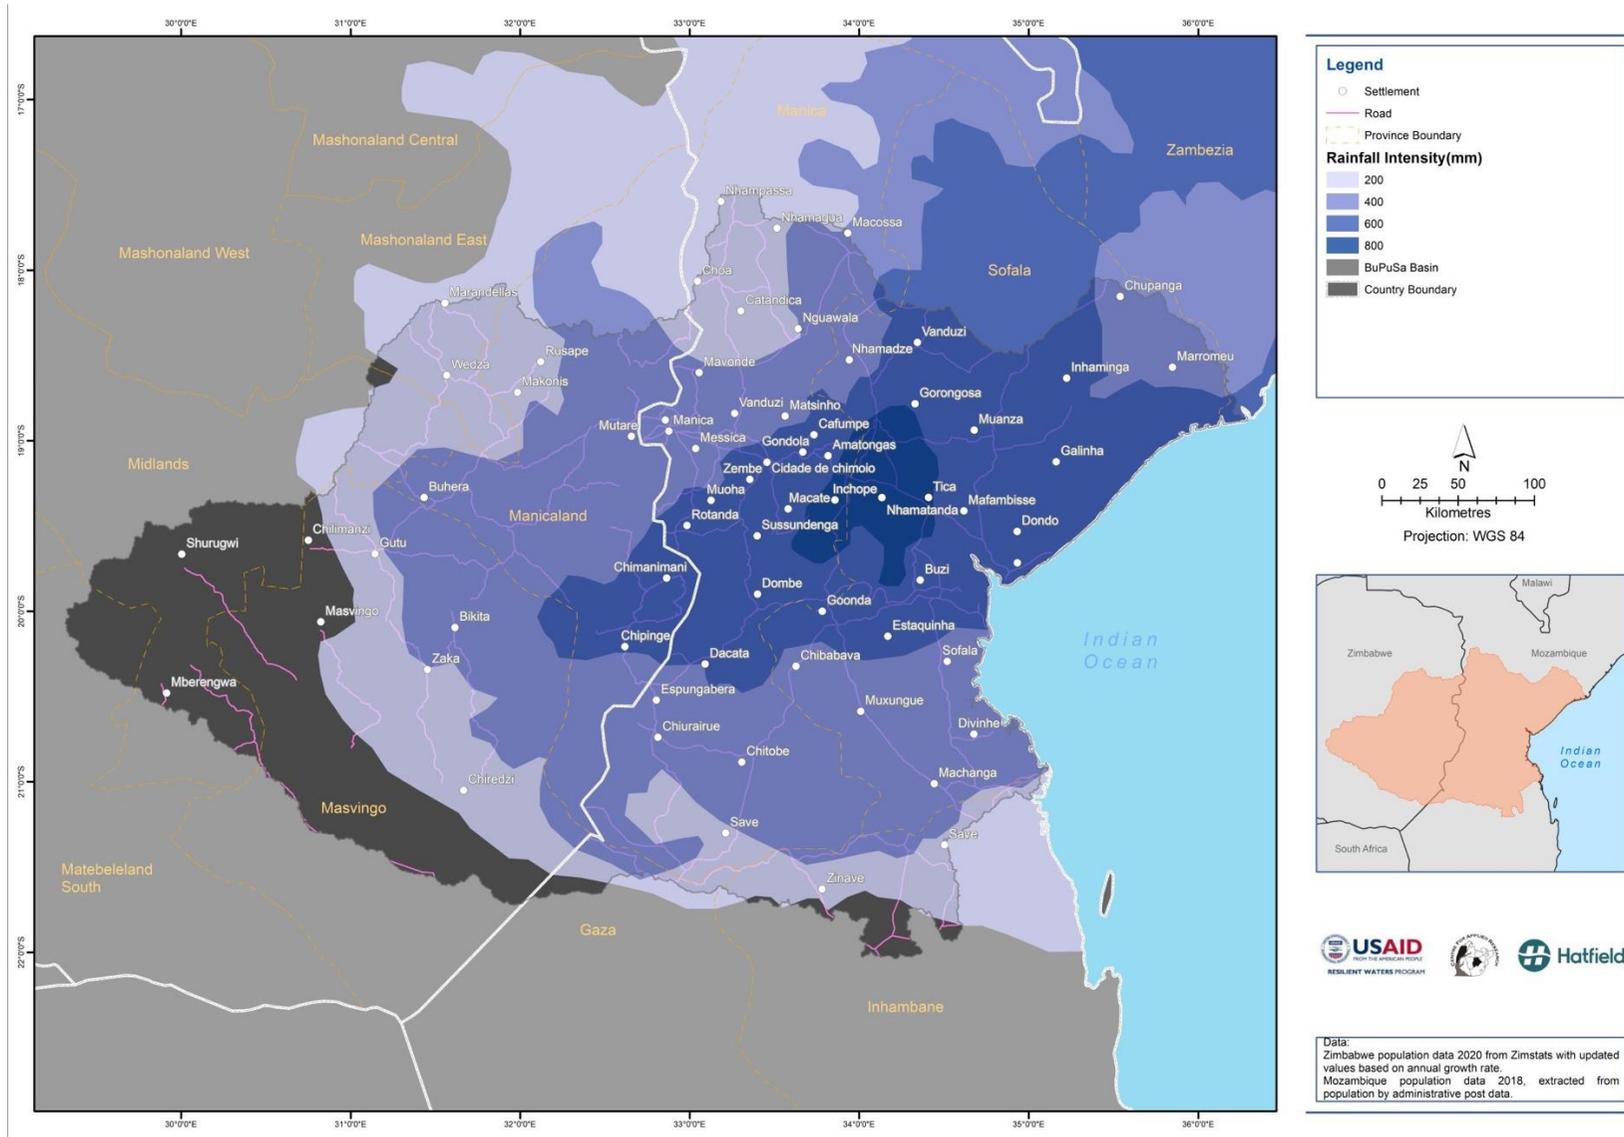
Figure 11: Cyclone Idai zone of influence based cumulative rainfall.

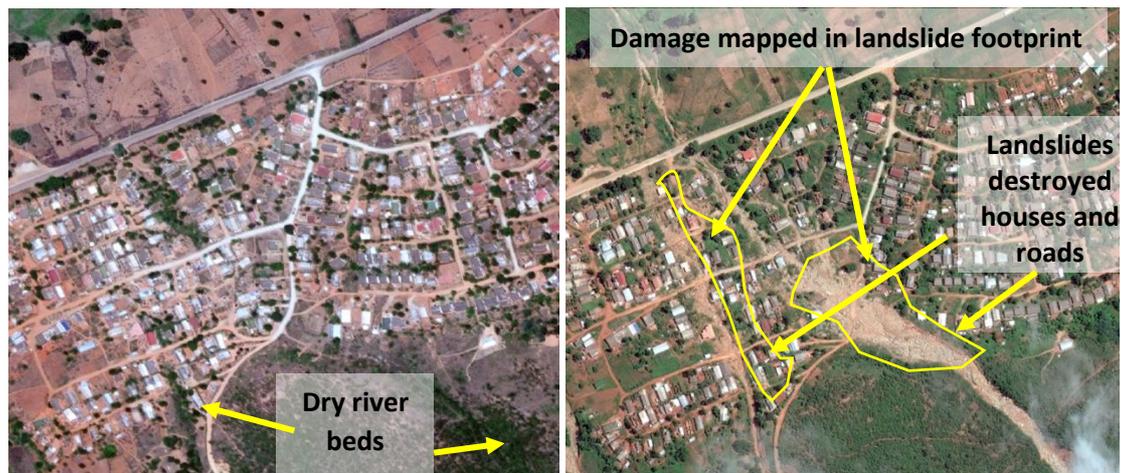
Figure 16: Before (left) and after (right) images for Chimanimani, Zimbabwe.

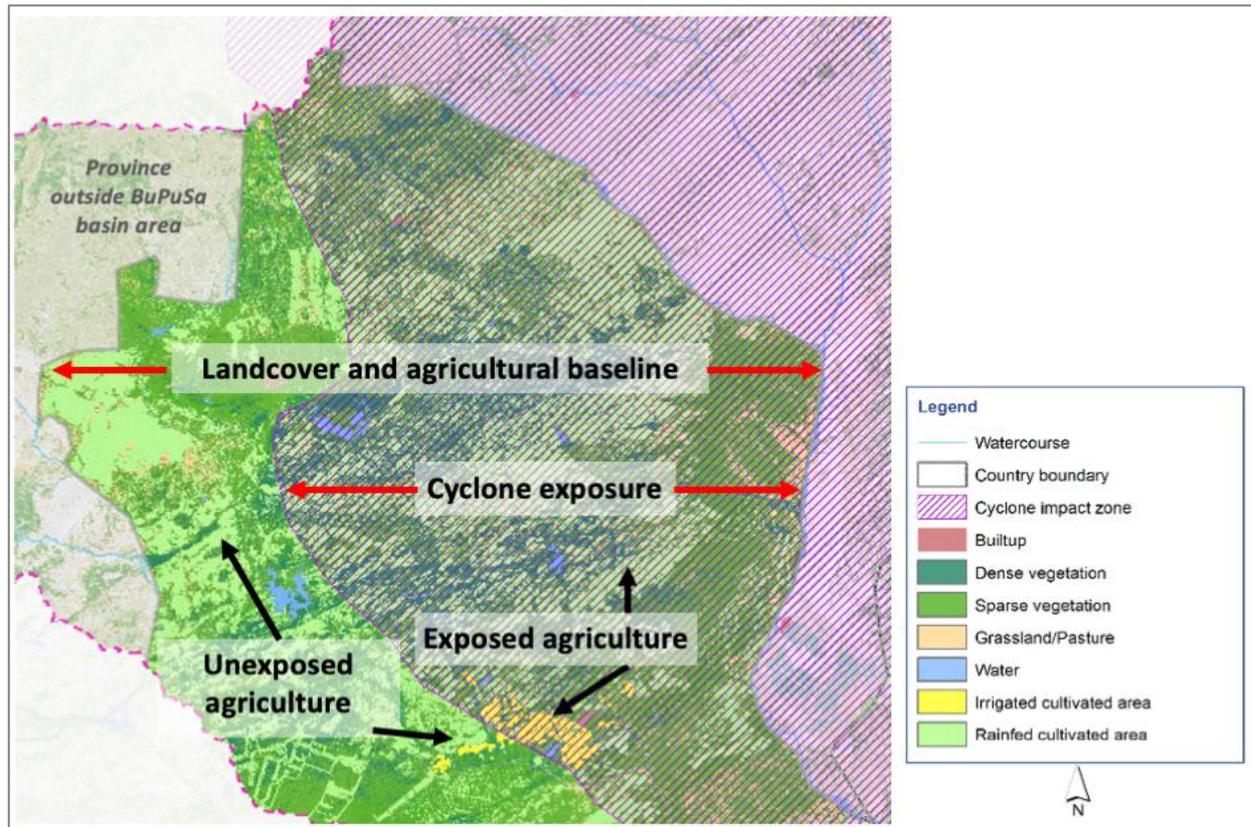
Figure 18: Visual explanation of the agriculture baseline and cyclone exposure concept.

The total area is the agriculture baseline, and the area inside the hatching is the exposed agriculture.

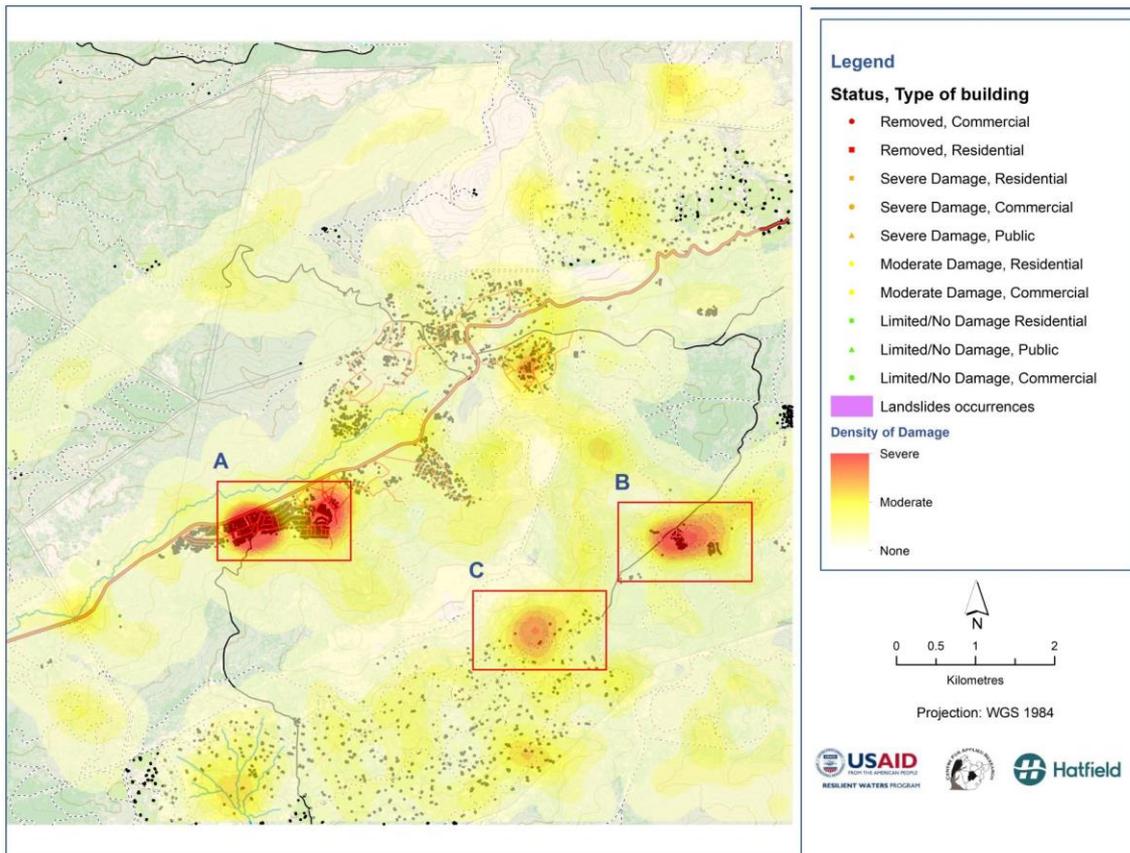
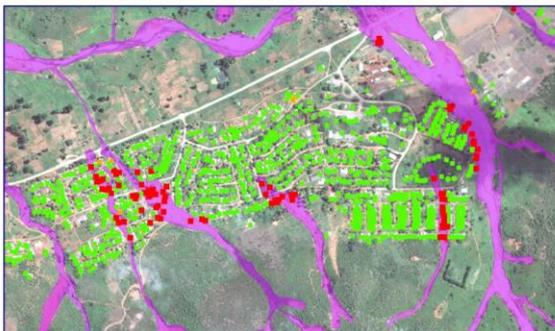
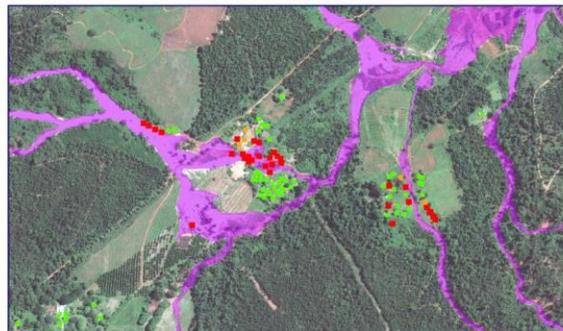
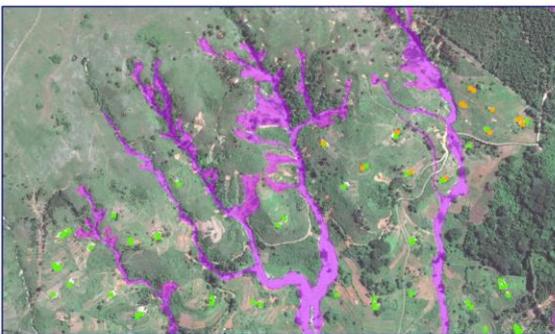
Figure 19: Building and road infrastructure damage density, Chimanimani.

The full results of the damage assessment for Chimanimani are presented in Figure 19, and Beira in Figure 20.

The comparison of the damage assessments in both areas shows that the damage patterns are substantially different. Damage in Chimanimani was localized around the devastating landslide paths, and to a lesser extent flooding in low-lying areas and general damage to small-holdings likely due to heavy rain and associated winds. The impacts in Beira were more widely distributed, likely driven by factors such as exposure to the elements, exacerbated by removal of sheltering trees, building density, and building materials.

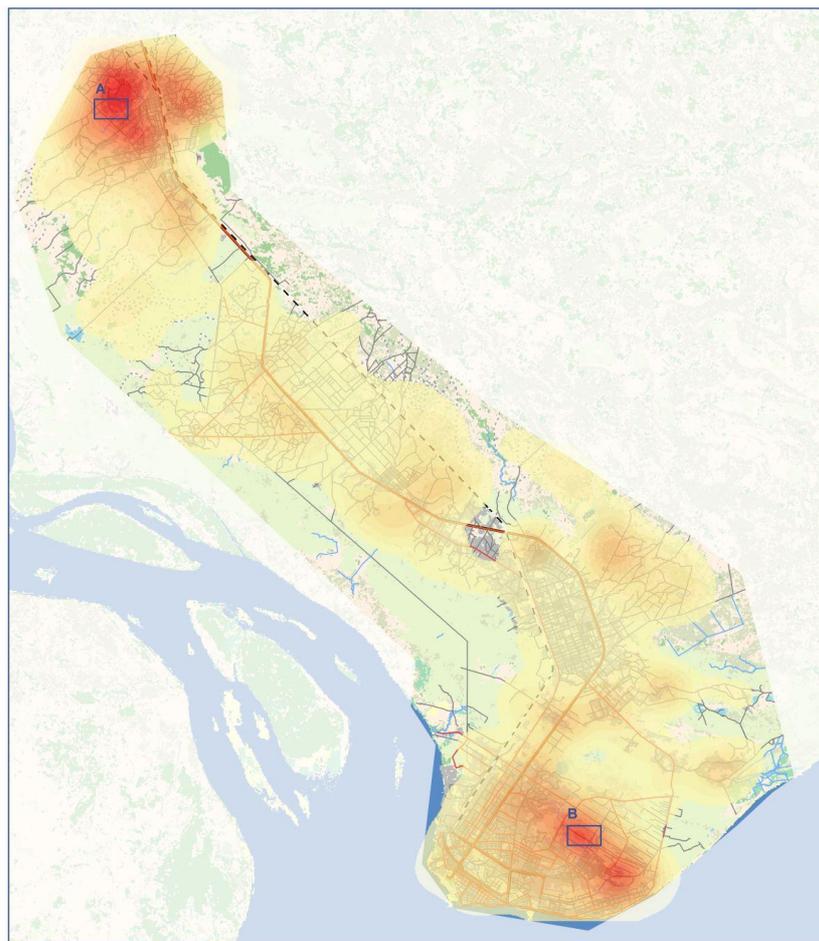
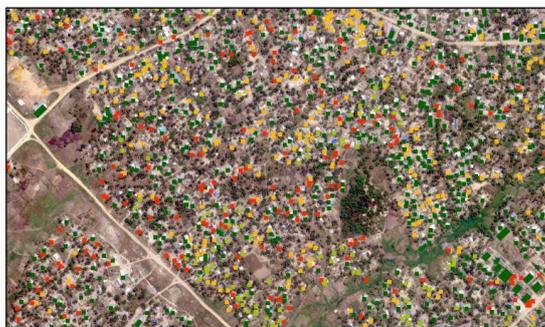
Figure 20: Building damage density, Beira.

In Beira, approximately 15 % of residential buildings were damaged, with 18 % of commercial buildings and 27 % of public/civic buildings sustaining some form of damage (Table 8).

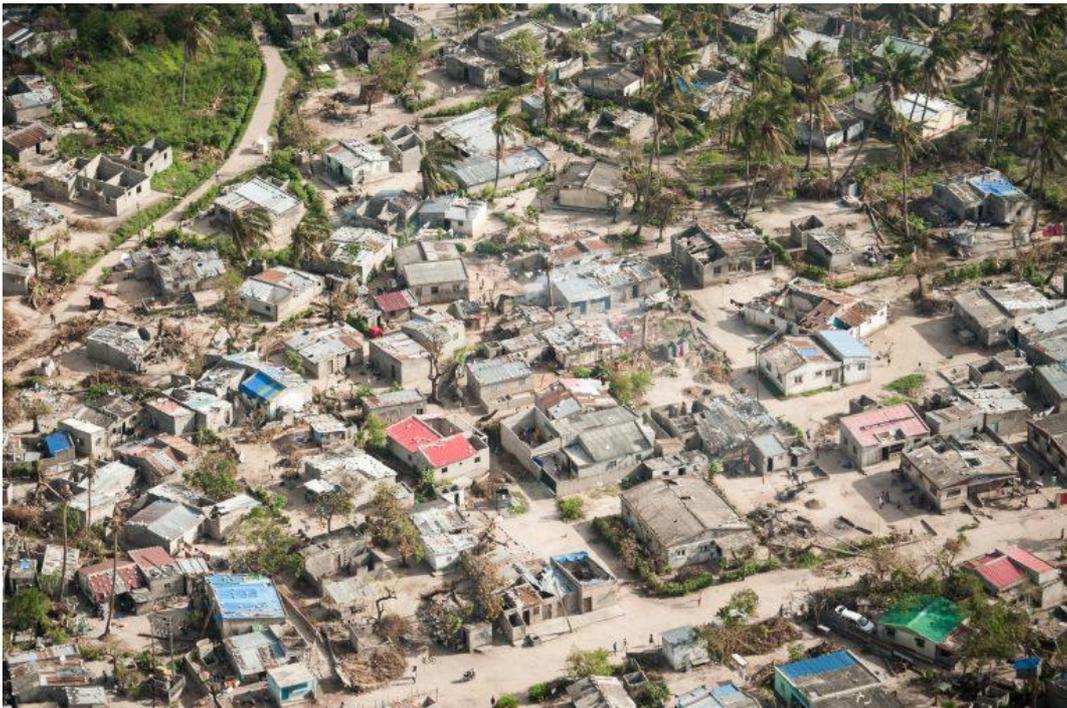
Figure 21: Homes in Beira damaged by Cyclone Idai, March 2019.

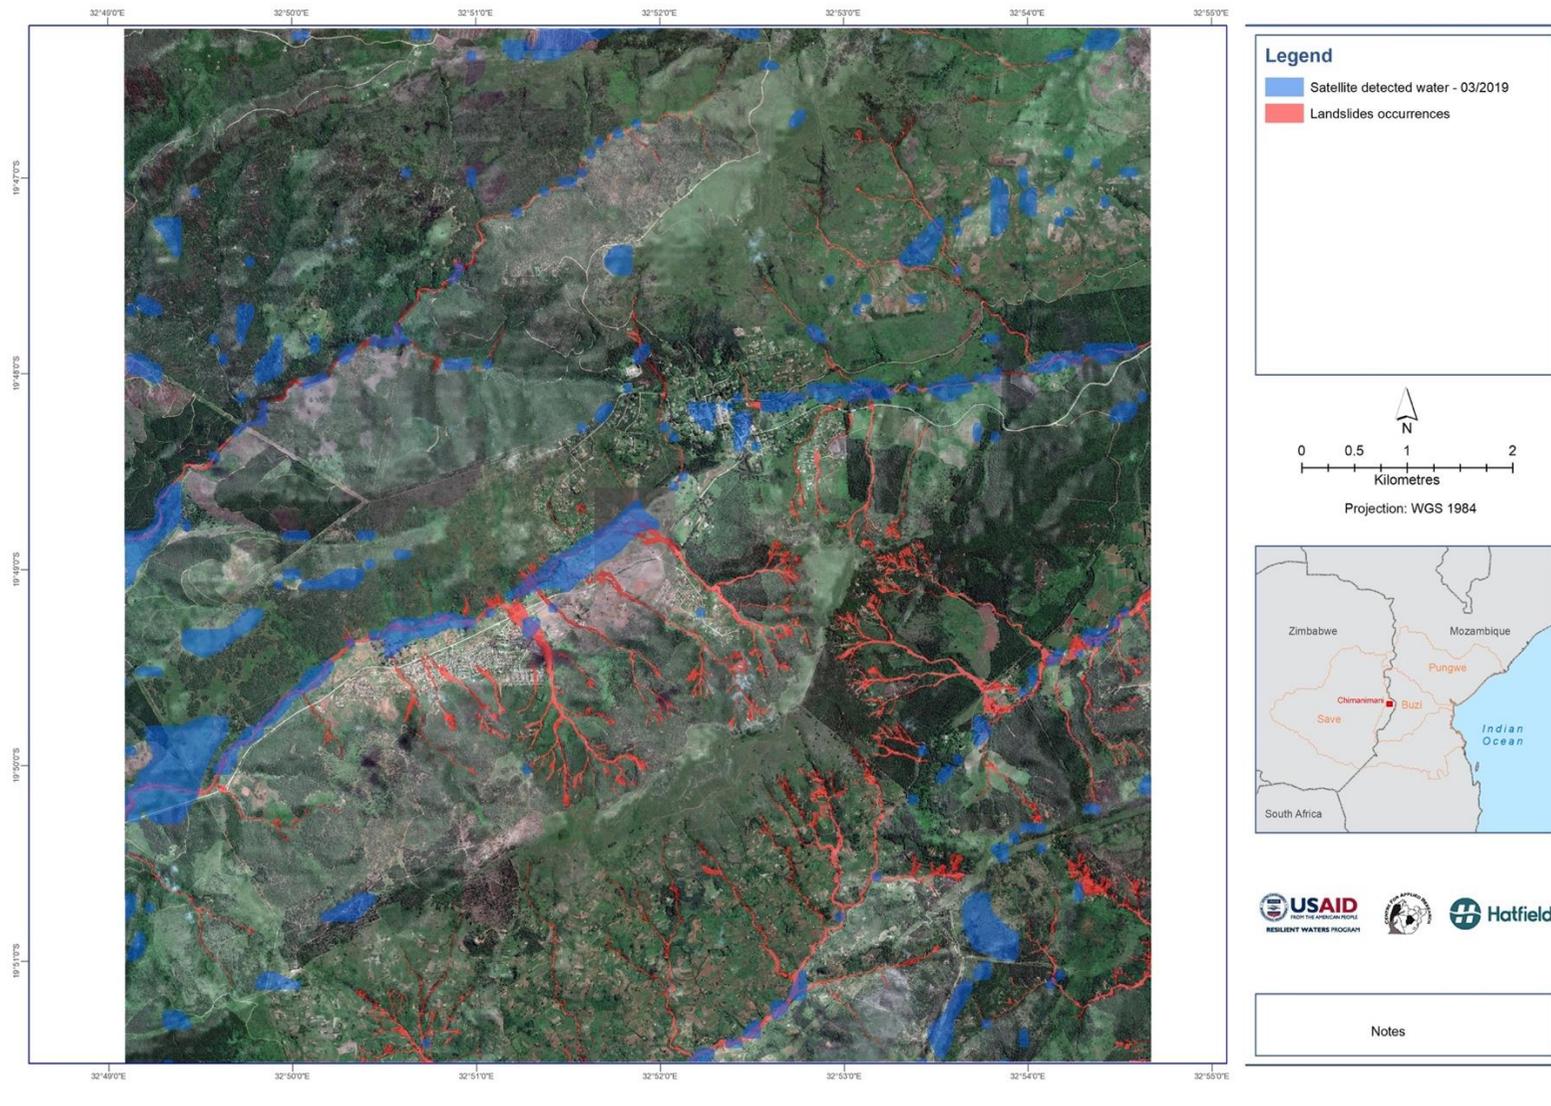
Figure 22: Flooded area and landslide analysis – Chimanimani, Zimbabwe.

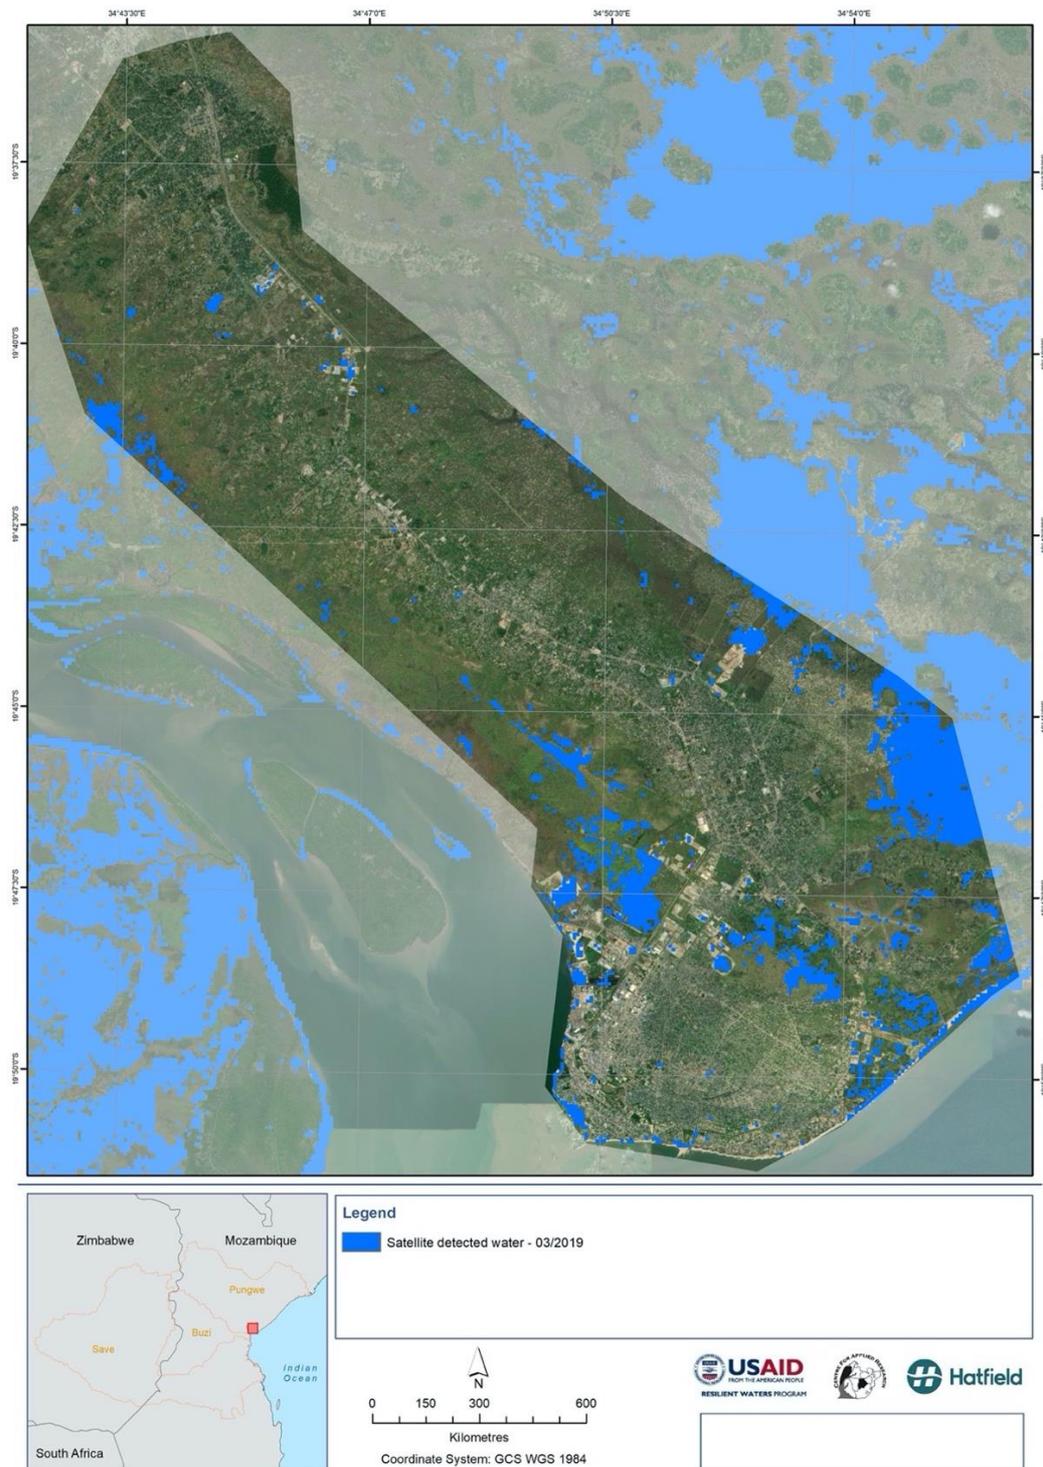
Figure 23: Flooded area analysis – Beira, Mozambique.

The results of the SAR-based flooded area analysis for Beira, Mozambique, created using Sentinel-1A data from March 2019 are shown in Figure 24. As can be seen in this map of Beira, most flooding took place in the unpopulated areas to the north of the main coastal residential district, to the east and further north-east, with limited flooding occurring in the main settlement itself.

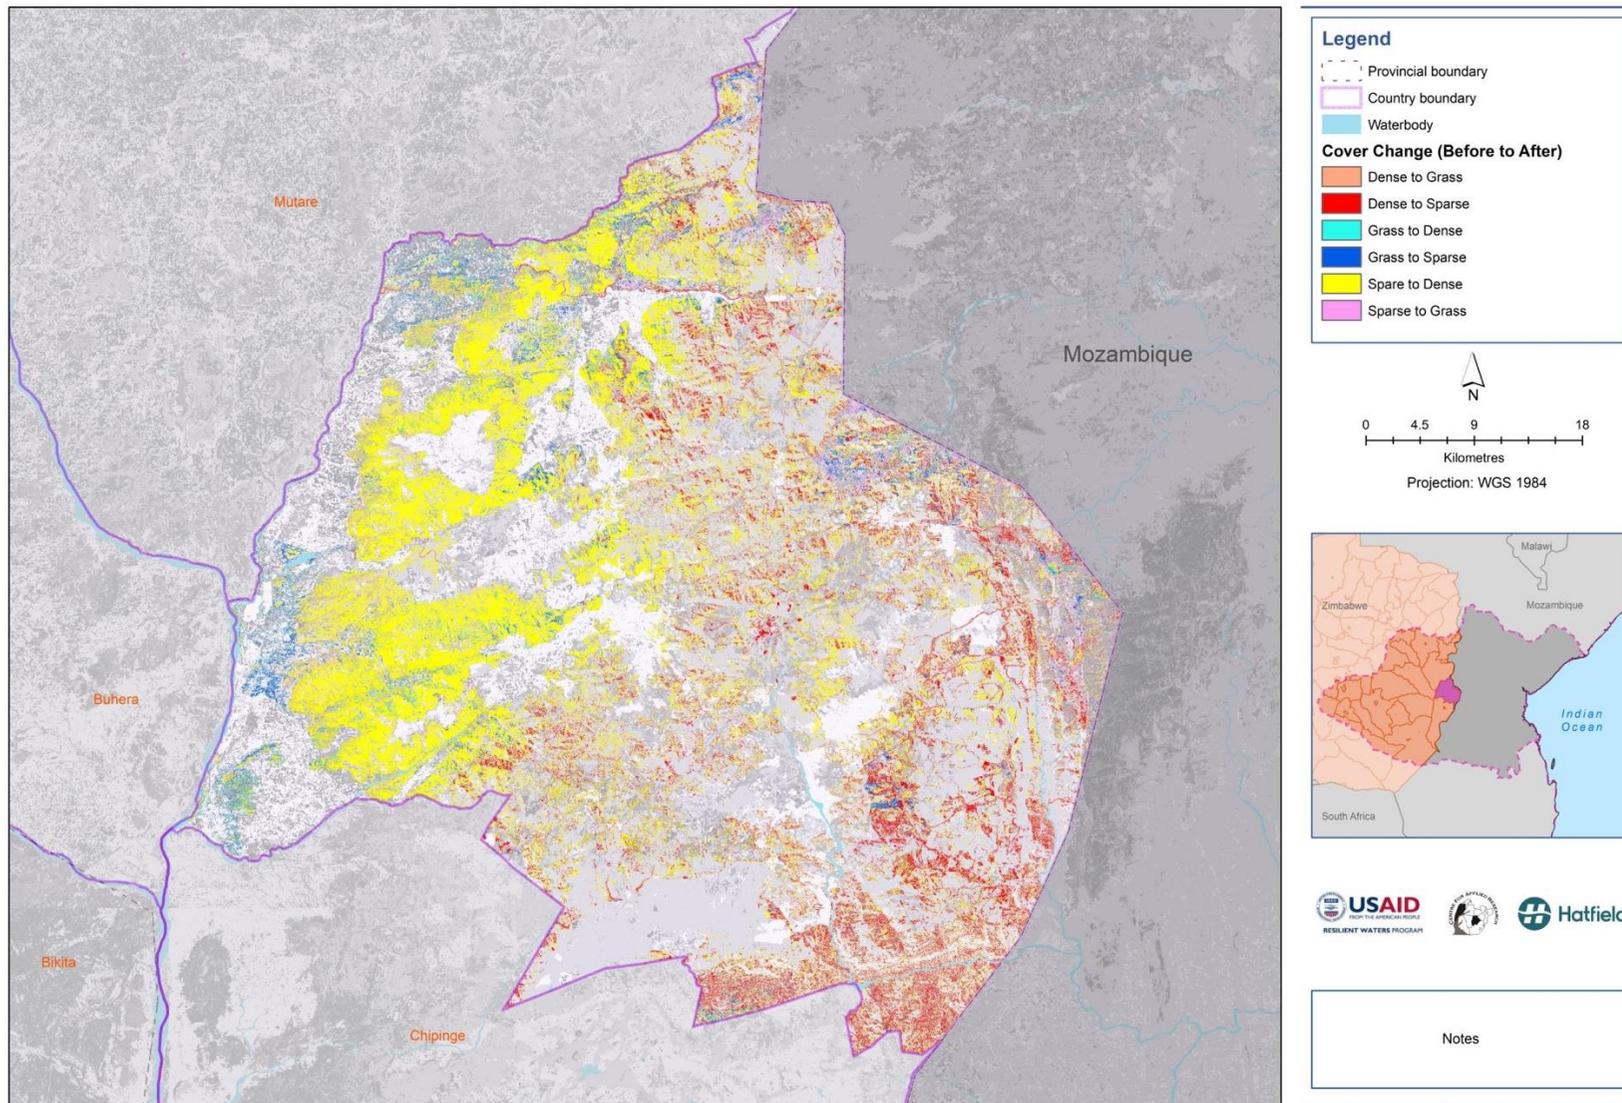
Figure 24: Landcover change for Chimanimani District.

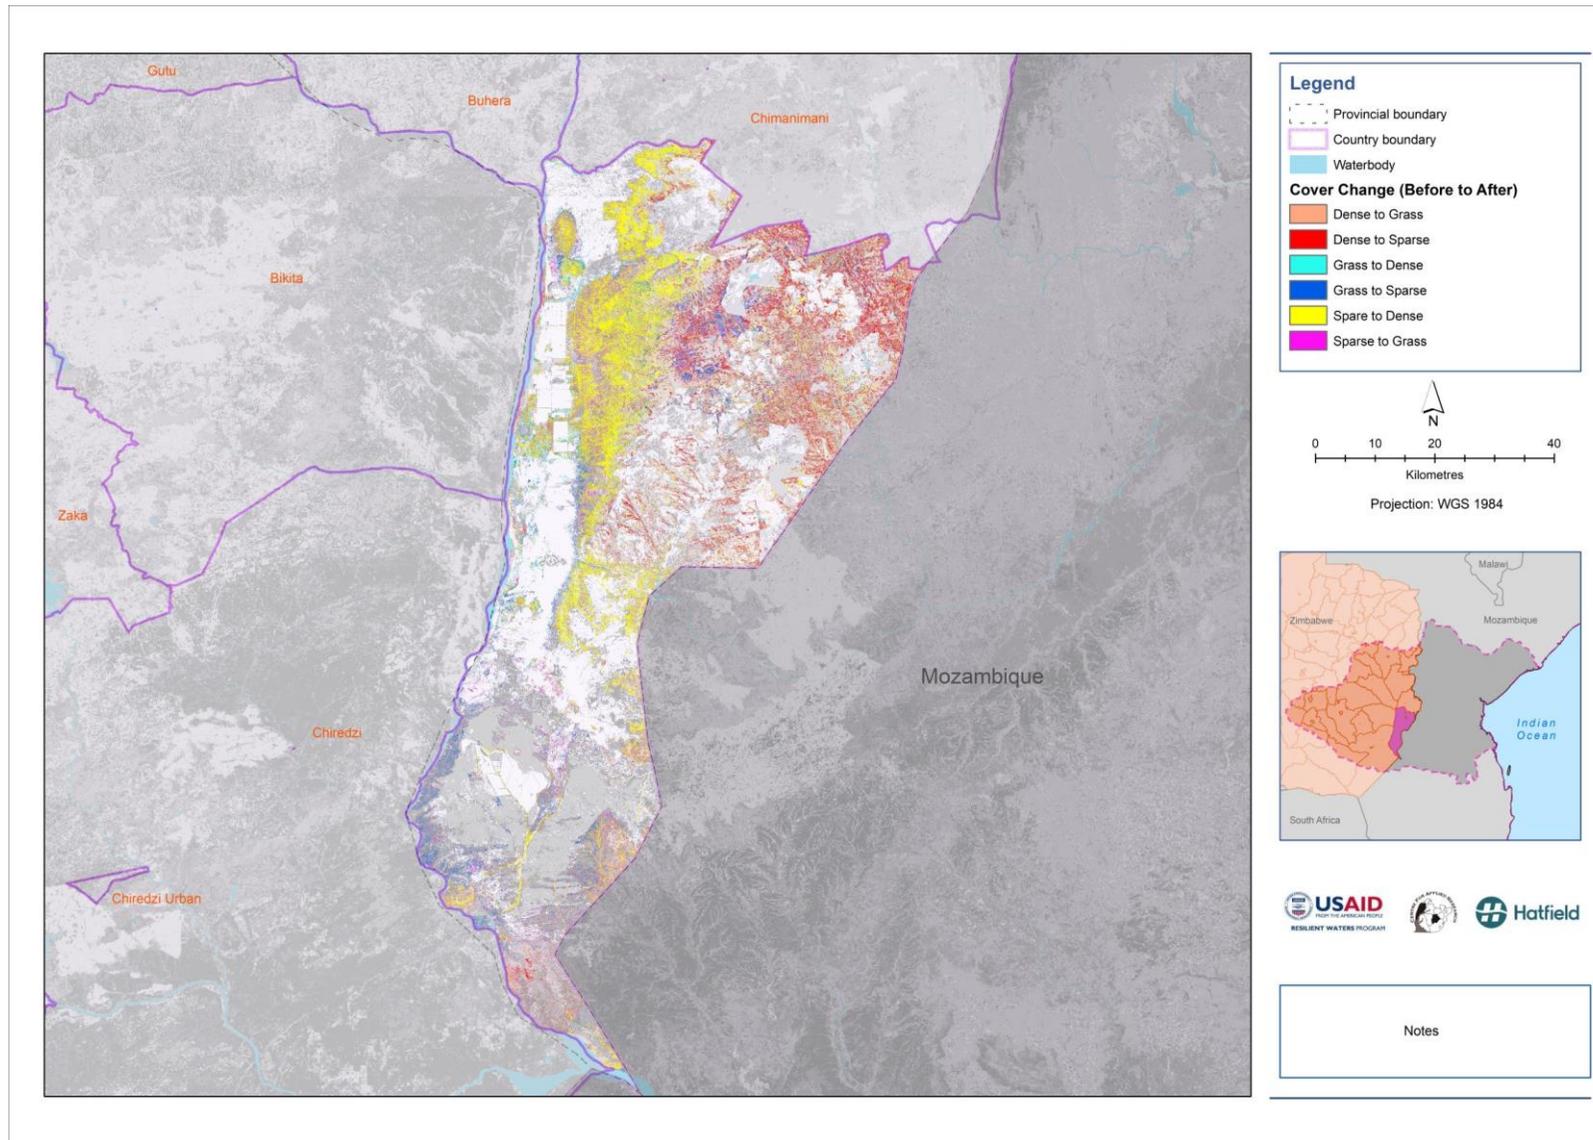
Figure 25: Landcover change for Chipinge District.

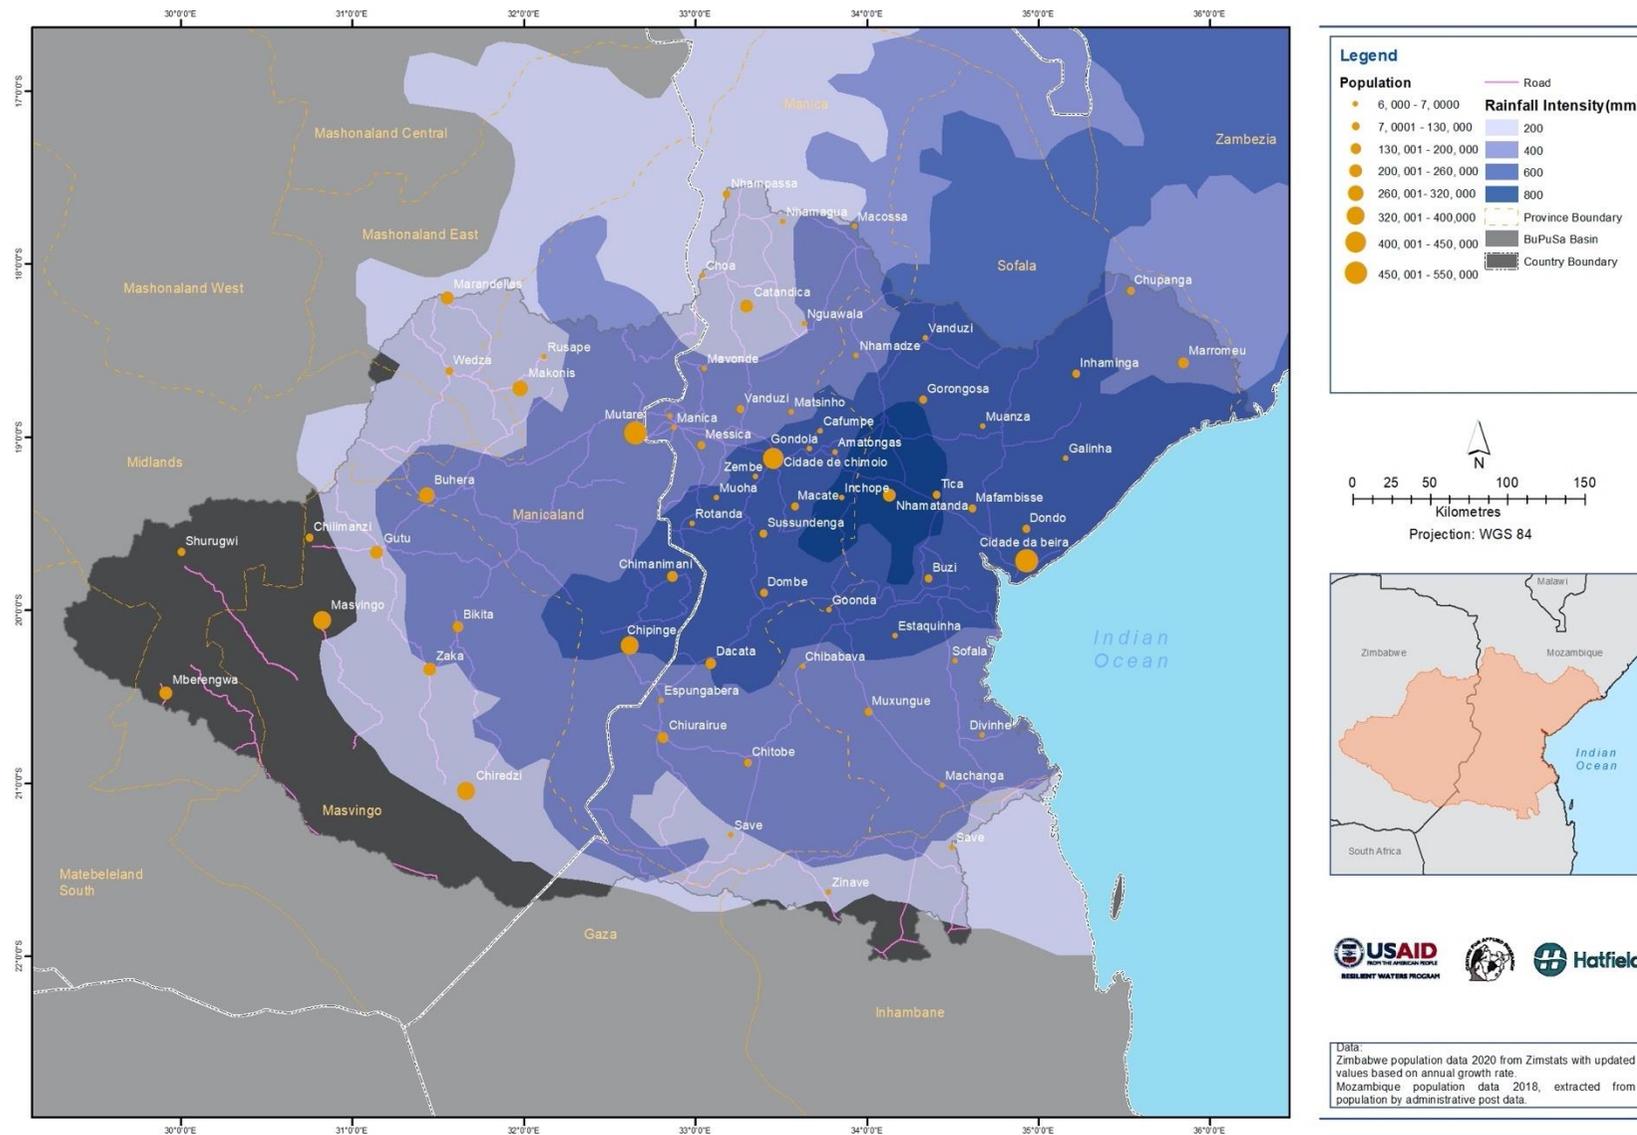
Figure 28: Distribution of cumulative rainfall estimates in relation to major settlements.

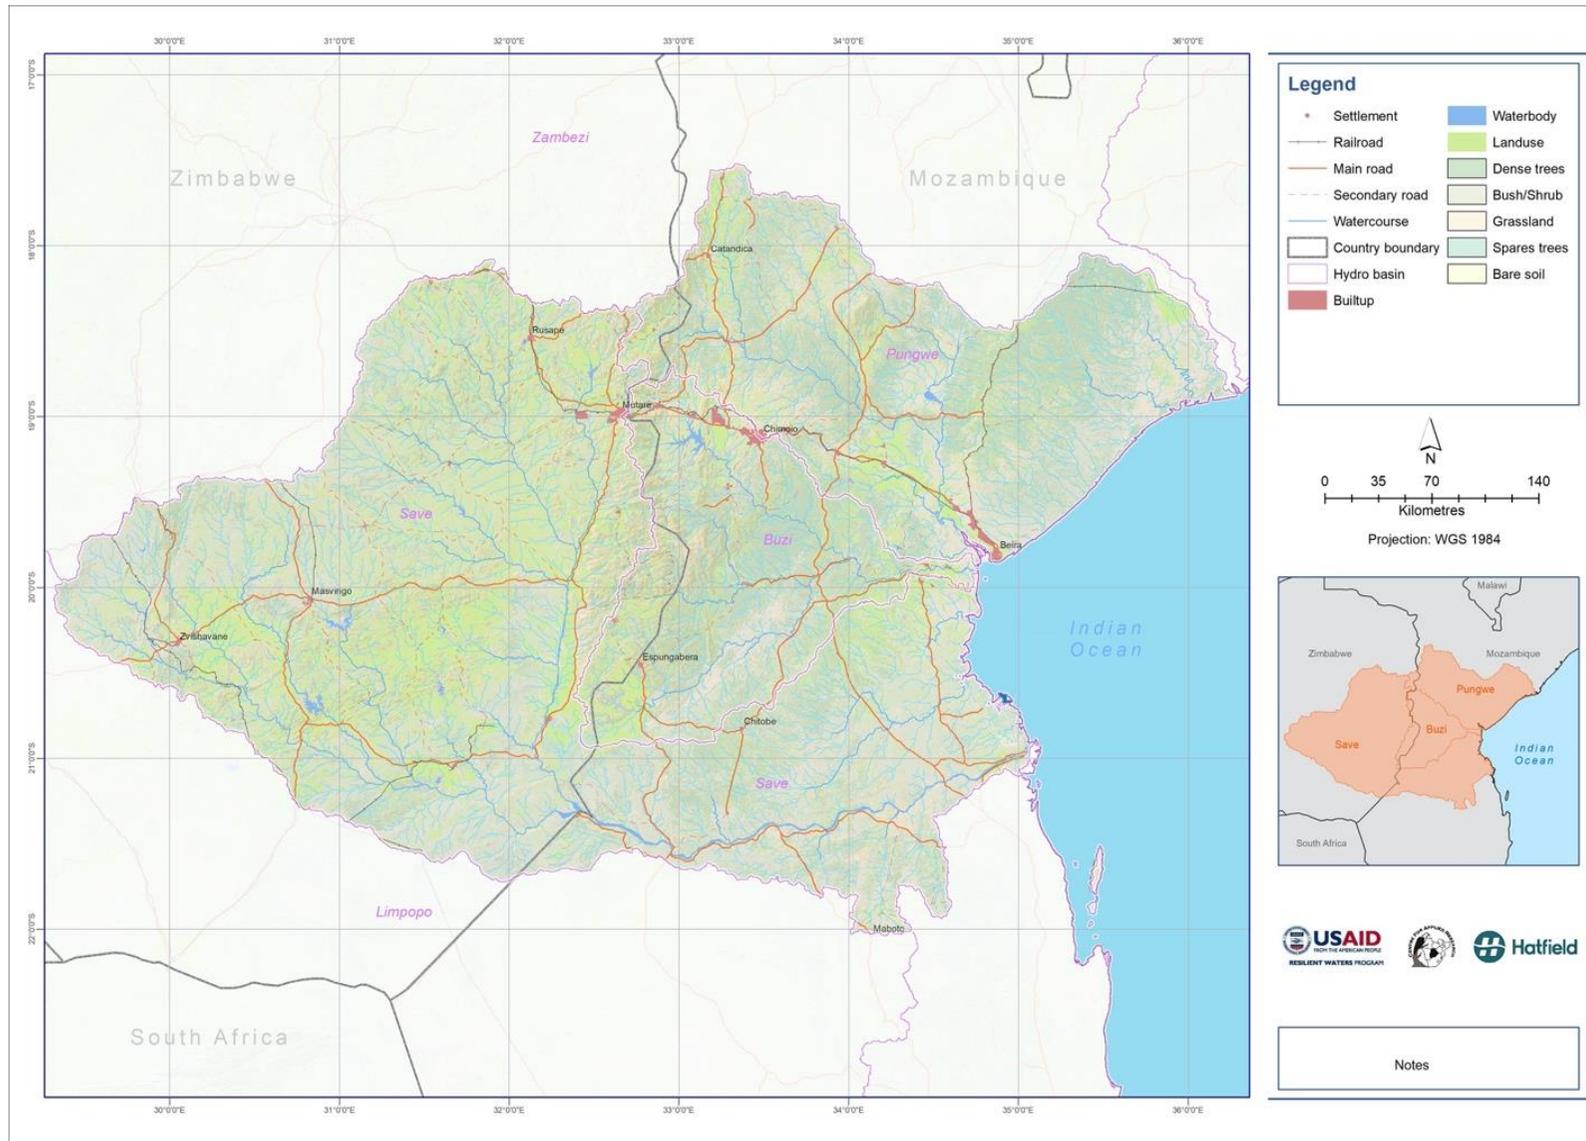
Figure 30: Road networks within the BuPuSa basins.

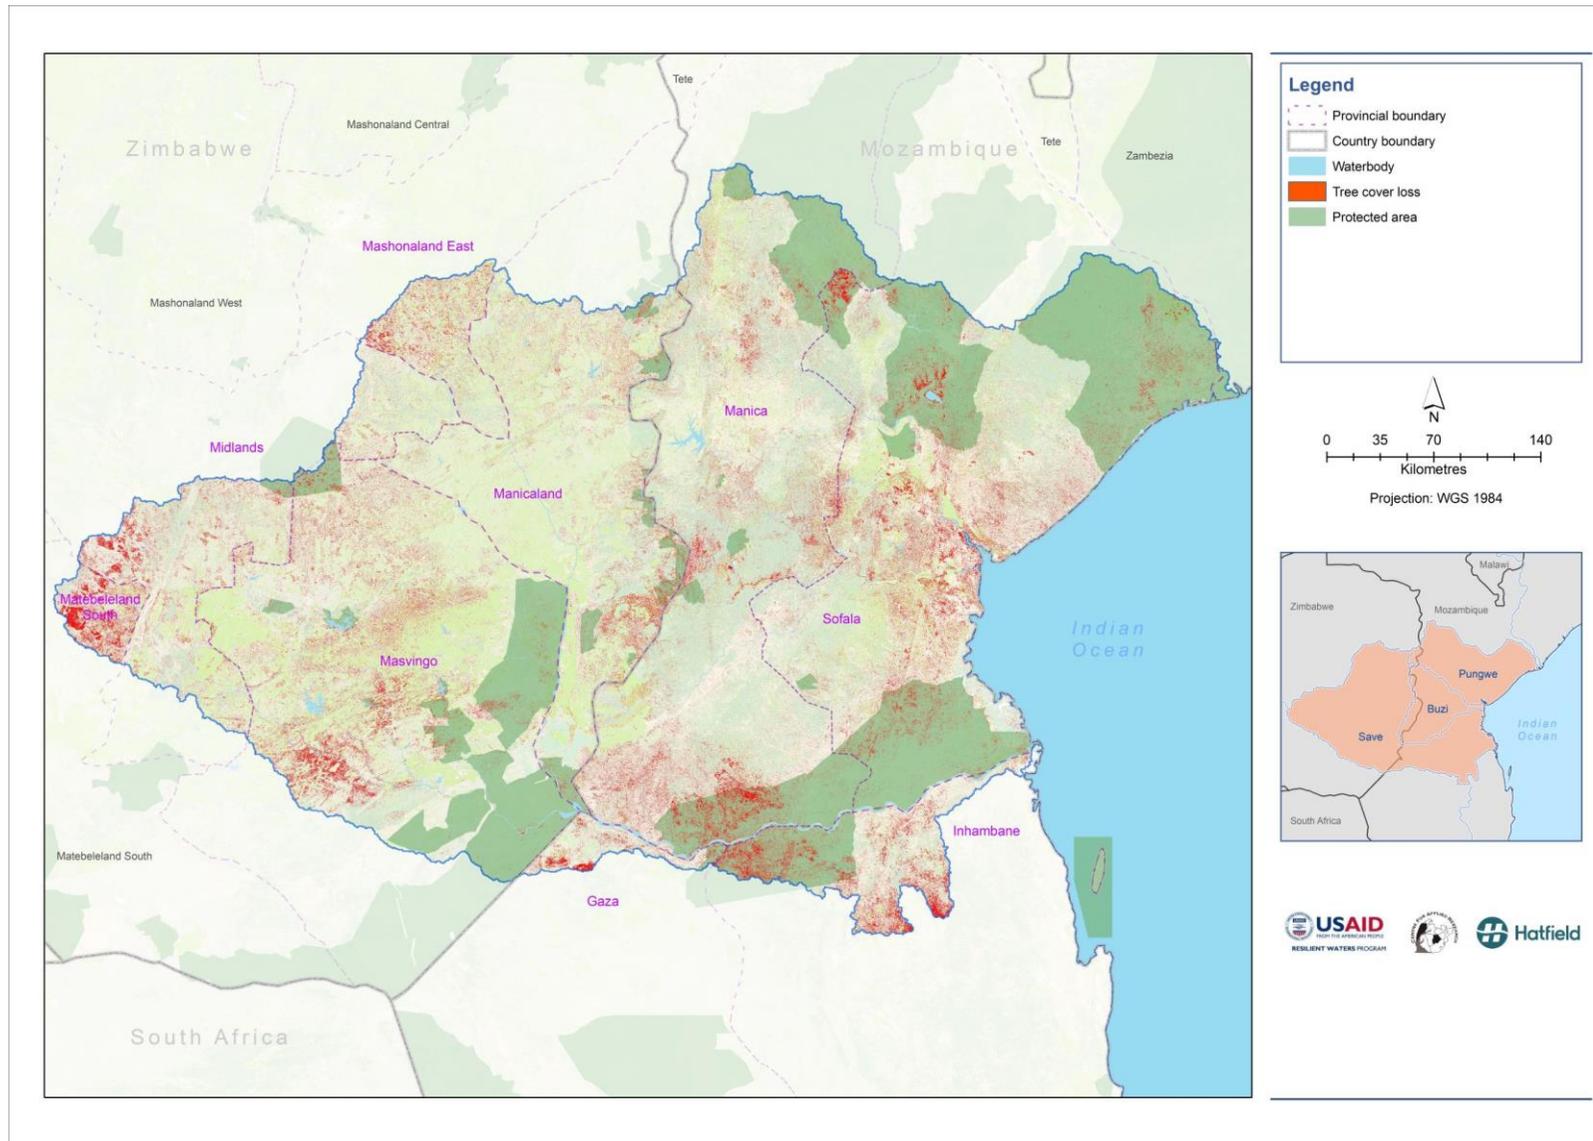
Figure 31: Estimated tree loss across the BuPuSa basins during and immediately following Cyclone Idai.
